My experience with SeaBis electrolysis control system

Marco Cianflone - captain/owner yacht UtopiaII

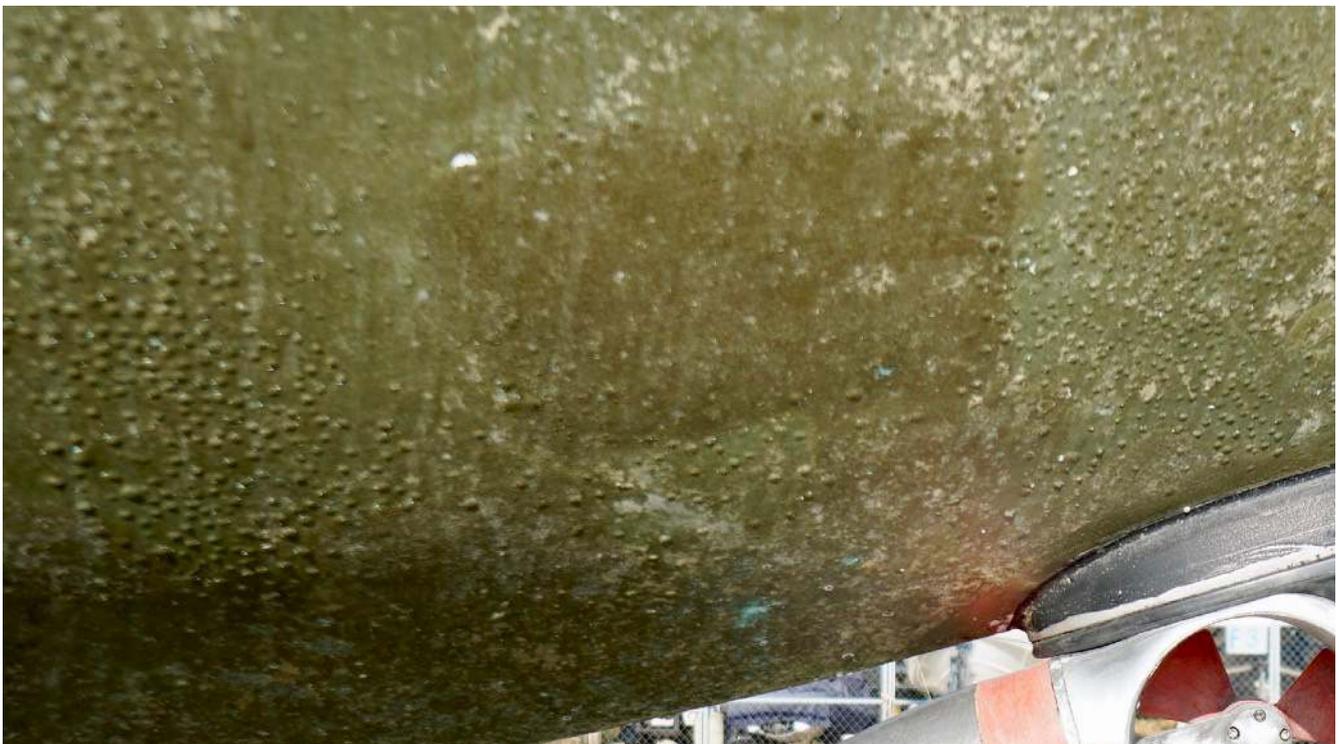
This picture below shows the boat on hard in Curacao 9 months after anti-fouling repainting and new electronics and new engine installations end of 2013. The hull under waterline completely full of blisters. This shot was taken in September 2014.

Mr Glen confirmed these blisters were caused by electrolysis. But much more was yet to come.

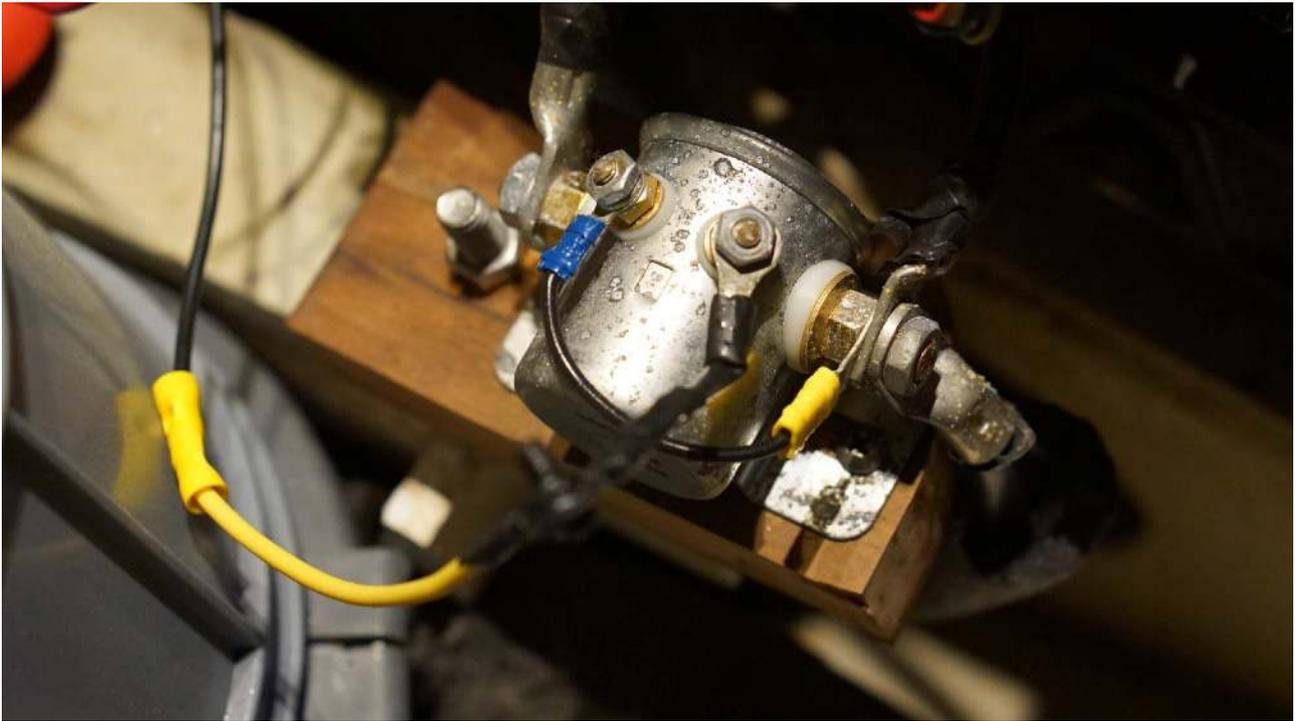
Remote Engine start solenoid

Cause 1: negative wire running from starting battery to non-insulated engine starter motor.

Repair 1: installation of remote solenoid on negative wire from starting battery to engine starter motor.

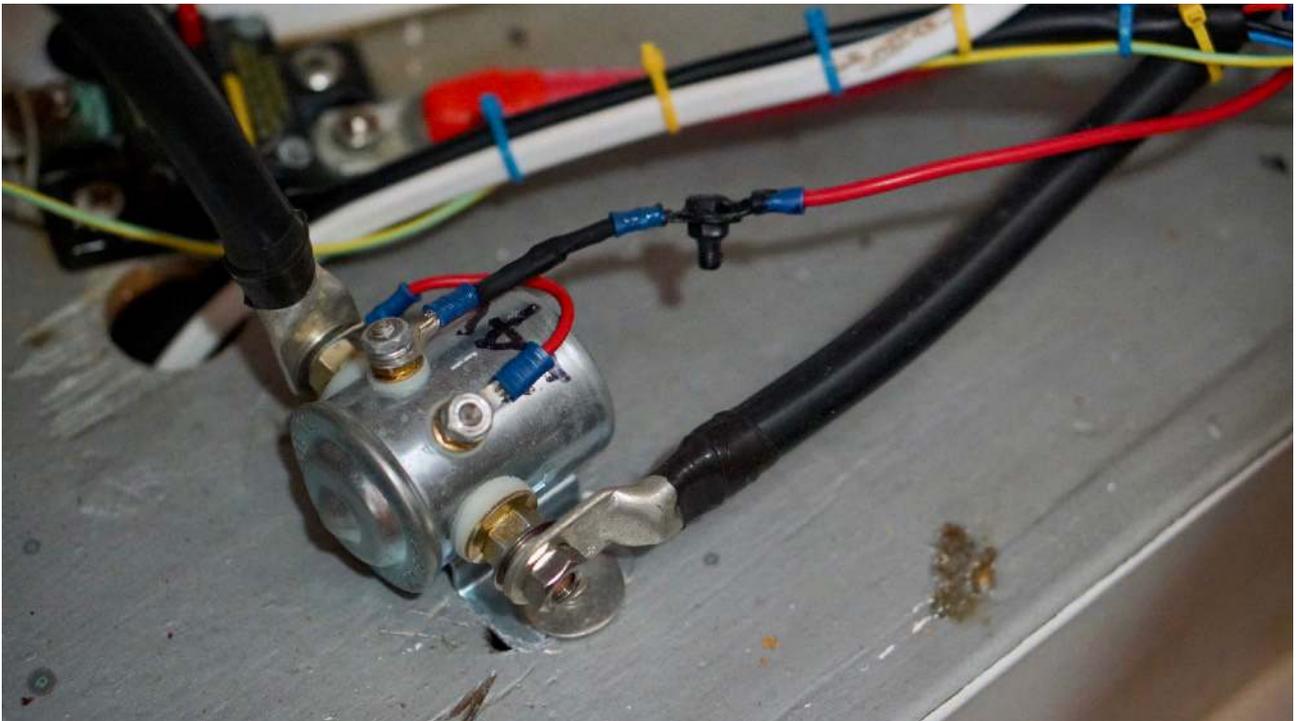
Remote Bow Thruster solenoid

Situation: critical electrolysis on positive side(red flash).

Cause: DC 12V to 24V converter(poor design).

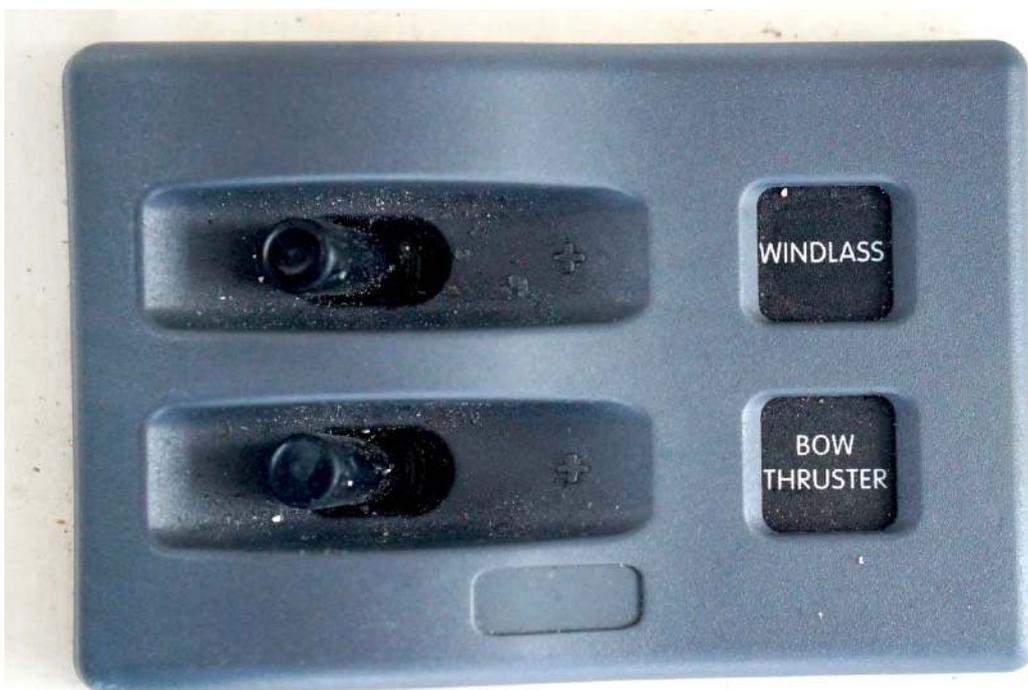
Windlass remote solenoid switch

Situation: critical electrolysis on negative side(red flash).

Cause: windlass DC electric motor negative brushes not insulated.

Repair: installation of remote solenoid on windlass electric motor negative wire.

How to eliminate: insulation of electric motor negative brushes.

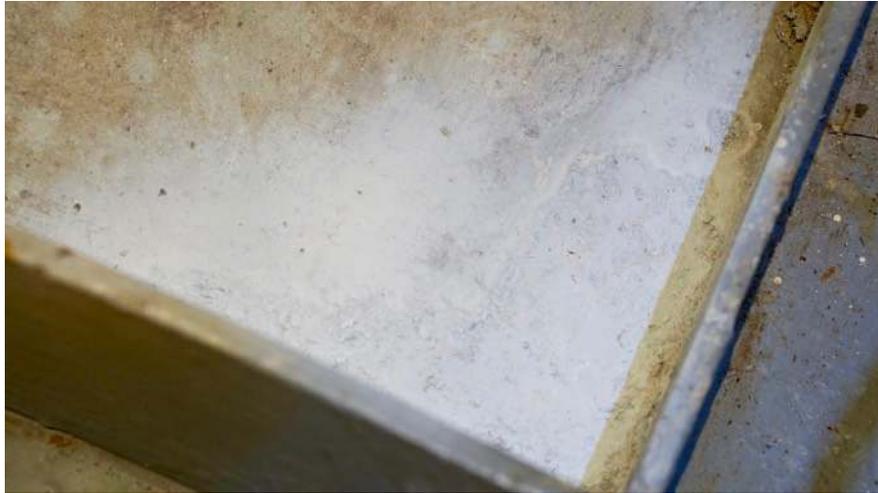
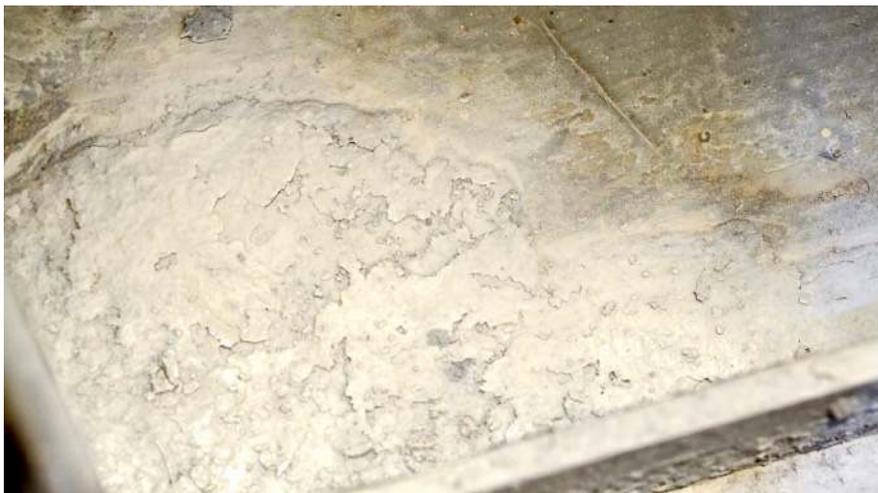
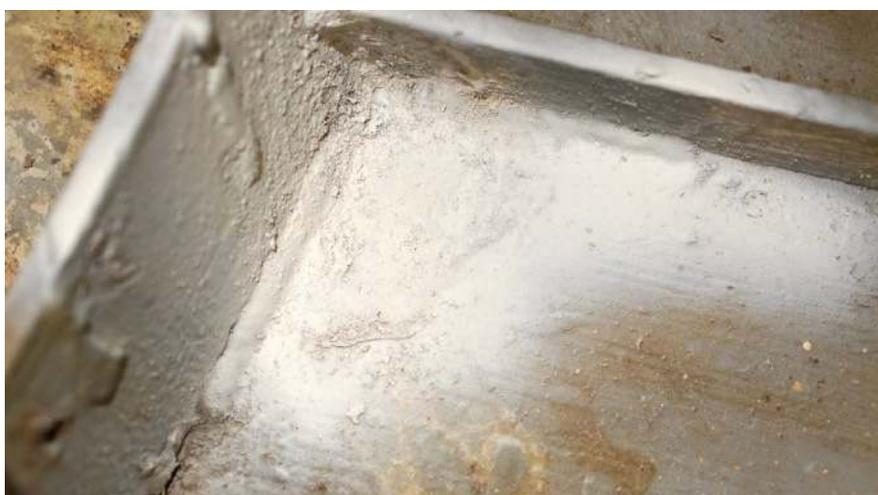
Rudder compartment. Faster than usual metal corrosion points. After SeaBis installation those corrossions ended. A rust stopper was applied followed by a normal white paint coating and corrosion don't develop ever since.

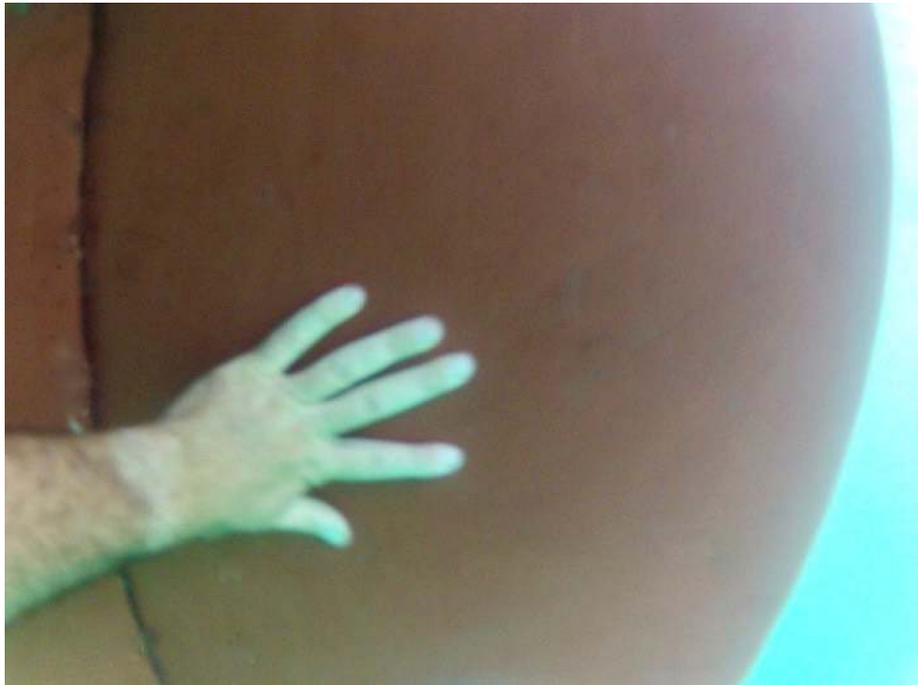
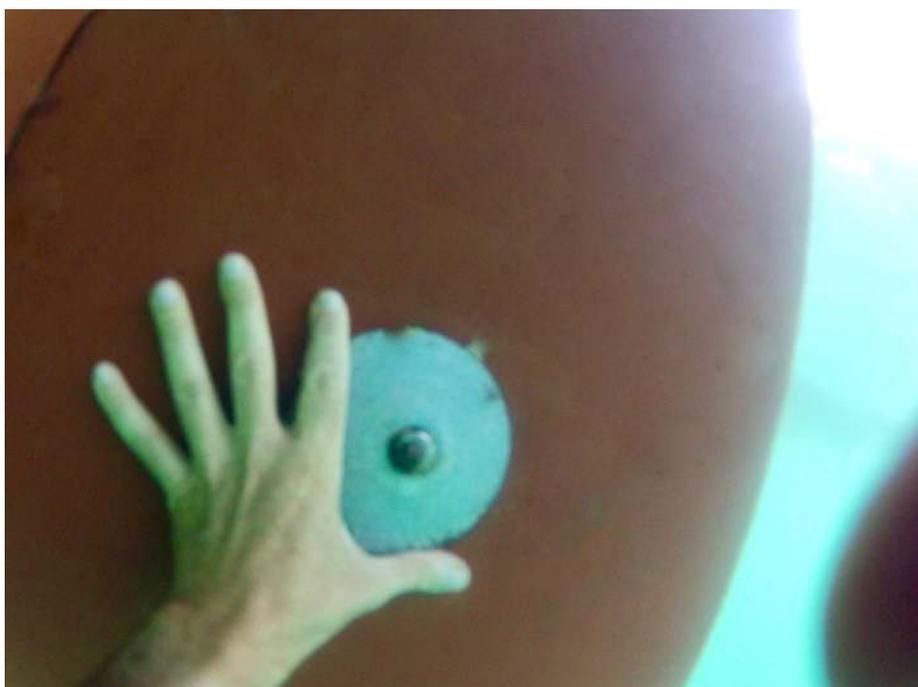
Unfortunately my only camera available for underwater use is a Go Pro hero 2, not made for close shots. The minimal angle of view is 127 degrees with a lot of fish eye effect and to make things worse the water is a bit murky but I decided to attach two shots taken in Tahiti in November 2017 to show the rudder with a complete absence of blisters and anodes not even 5% consumed after almost one year.
